Case study: **Plasmet ZF** for pipe-bridge

Structurally dangerous pipebridge restored to 'as new' condition.

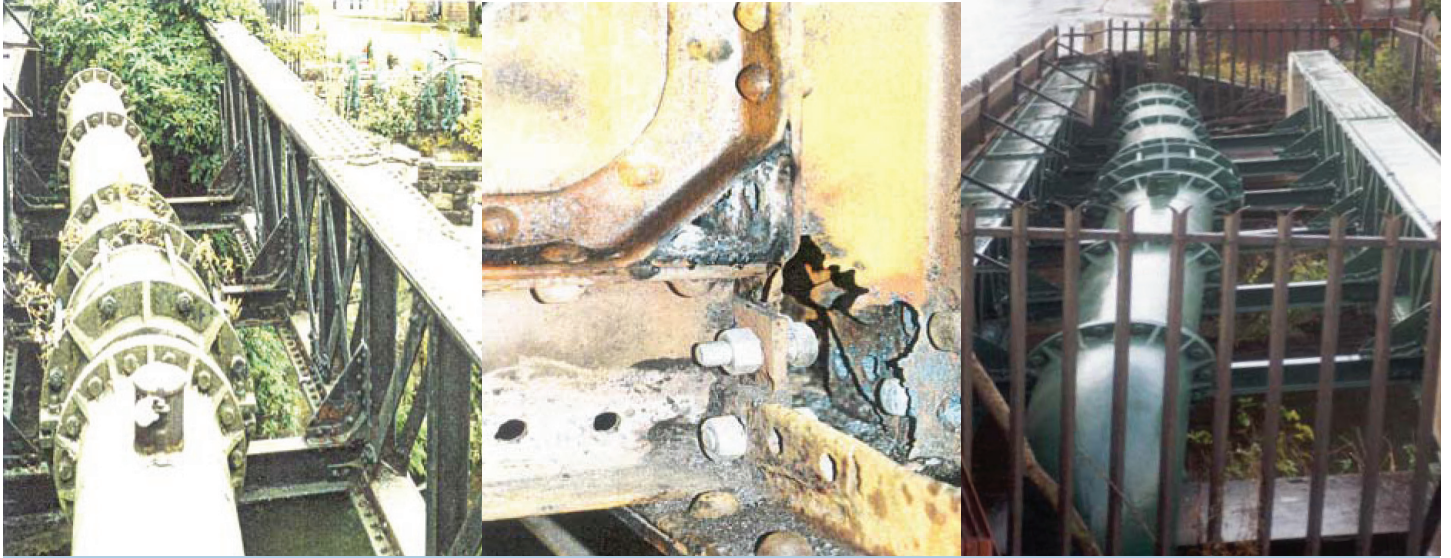
A full structural survey was carried out, revealing that extensive repair work was required. Corrocoat carried out this repair schedule, and fully corrosion protected the bridge to ensure extended maintenance free life for the future.

Left: [Pipe-bridge before refurbishment.](#)

Middle: [Lower chord to vertical joints after grit blasting.](#)

Right: [Job completed, bridge fully refurbished.](#)

- Grit blast to ISO 8501-1 cleanliness standard SA 2½.
- All joints encapsulated using Corrocoat's Polyglass material.
- Total structure and externals of the pipe were treated to two coats of Plasmet ZF and a top coat of Plasmet ZX.
