# Case study: Fluid efficient coating of a pump casing

# Fluiglide treatment of the internal surfaces of a 14/12 hsc pump.

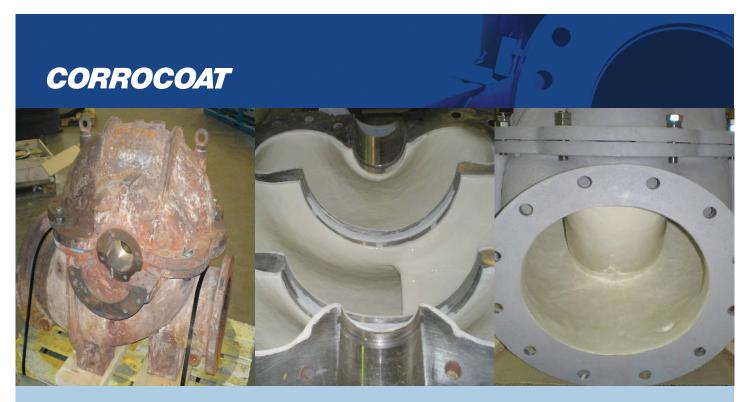
# Photographs

Left: Pump casing as received.

Middle: Internals coated prior to ring land casting.

Right: Pump fully re-furbished.

Grit blasted internally to ISO 8501 - Cleanliness Standard SA 21/2.

Coated internally using Corroglass 600 Series to a minimum 750 DFT.

Thickness checked.

Spark tested at 9.5 Kv.

Single coat of Fluiglide applied.

Grit blasted externally to ISO 8501-1 – Cleanliness Standard SA 2 and applied one coat of Plasmet ZF.
