Case study: Residuals separator

Separator vessel found to be in excellent condition after 14 years in service.

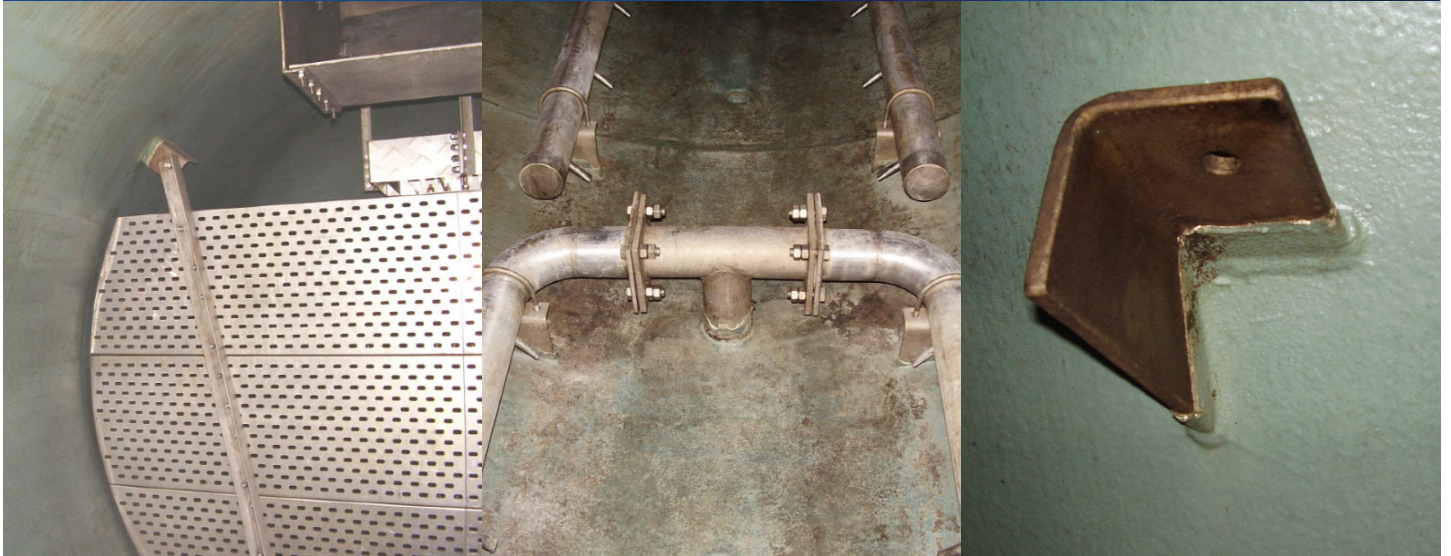
Photographs

The coating was in excellent condition. It was free from blisters and integrally sound.

There were a small number of mechanical defects, particularly in the manway area. It was assumed these were cause during the inspection/cleanout.

Left: [Residuals separator general view.](#)

Middle: [Residuals separator, sand jet pipework.](#)

Right: [Residuals separator, internal furniture.](#)

(Note: this picture shows no undercutting or delamination from the exposed edge).

Minor repairs were executed to these areas by the Corrocoat application team. Full spark testing was carried out prior to the vessel being returned to service.
